NAVAL AVIATION SAFETY CENTER

1. AIRCRAFT ACCIDENT BOARD APPOINTED BY Commander Air Wing EIGHT	2. SERIAL NO. 2-65A	3. DTG (LOCAL) OF MISHAP 261935A	4. MODEL AIRCRAFT F4B	5. BUREAU NUMBER 150410
6. TO: Commander, Naval Aviation Safety Center	9. LOCATION OF MISHAP IAT 12014N Long 10029.5E		10. DAMAGE ALFA	
7. VIA: Commanding Officer, VF-74 * Commander Air Wing Eight	8. RC Commanding Officer, USS FORRESTAL Commander Carrier Division FOUR Commander Naval Air Force, ATLANTIC	11. TIME OF DAY NIGHT	12. TIME IN FLIGHT 0+01	13. FLIGHT CODE 346
14. CLEARED FROM: CVA-59 TO: CVA-59		15. TYPE CLEARANCE LOCAL VFR	16. AIRSPEED UNKNOWN	17. A/C WEIGHT 46,000#
18. BRIEF DESCRIPTION OF MISHAP A/C flew into water shortly after catapult launch		19. ELEVATION AT TIME OF MISHAP SL 0 ft TERRAIN		
20. LIST MODEL, BUNO, REPORTING CUSTODIAN AND DAMAGE CLASSIFICATION OF ANY OTHER A/C INVOLVED (Complete OPNAV Form 3750-1 for each A/C) NA

LCDR MANFREDI and his Radar Intercept Officer, ENS LEE, were launched in F4B BuNo 150410 at 1935A, 26 November 1965, from the number four catapult of USS FORRESTAL (CVA-59) operating in the Western Mediterranean Area. Initial aircraft pitch attitude following the launch was s

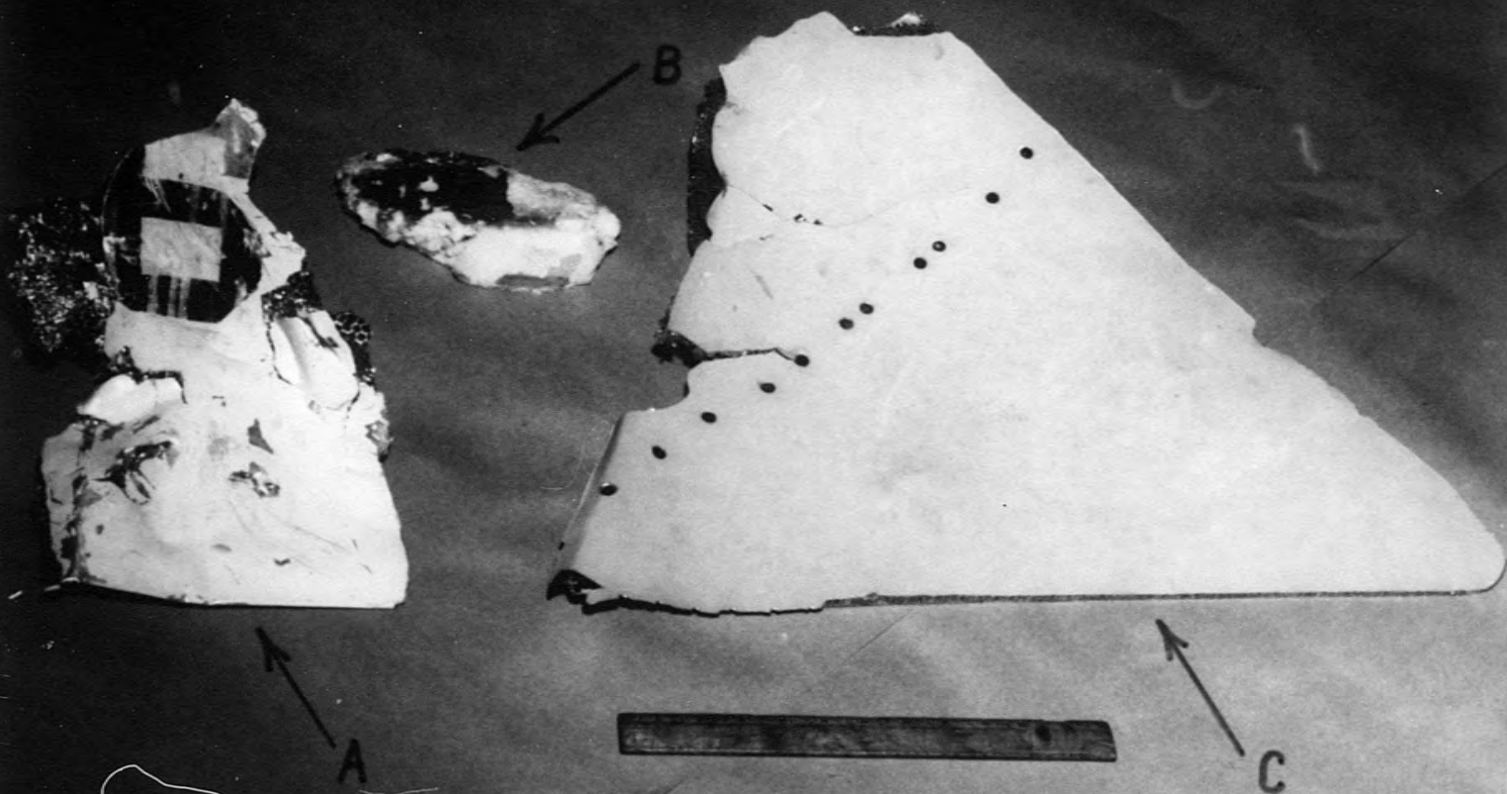
ENCLOSURE (16)

VF-74 SERIAL 2-65A, 26 NOVEMBER 1965, F4B BUINO 150410, PILOT MANFREDI
PHOTO OF: (A) SECTION OF TRAILING EDGE FLAP (UNDETERMINED STARBOARD OR PORT)
(B) PIECE OF STYRAFOAM PLASTIC (SAME WIDTH AS GEAR DOOR)
(C) PIECE OF INBOARD UPPER WING SURFACE.

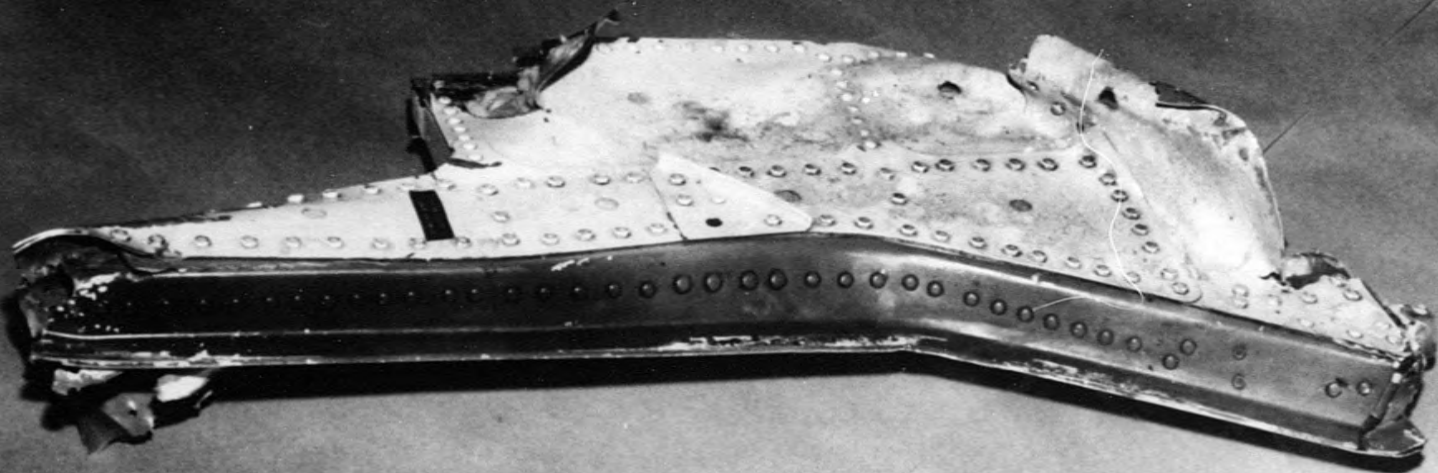
ENCLOSURE (17)
SPECIAL HANDLING REQUIRED IN ACCORDANCE WITH OPNAV INST 2750.6

VF-74 SERIAL 2-65A, 26 NOVEMBER 1965 F4B BUNC 150410, PILOT MANFREDI
STARBOARD MAIN LANDING GEAR DOOR SHOWING FORWARD EDGE (NOTE NO ABRASIONS)
AND INBOARD SURFACE

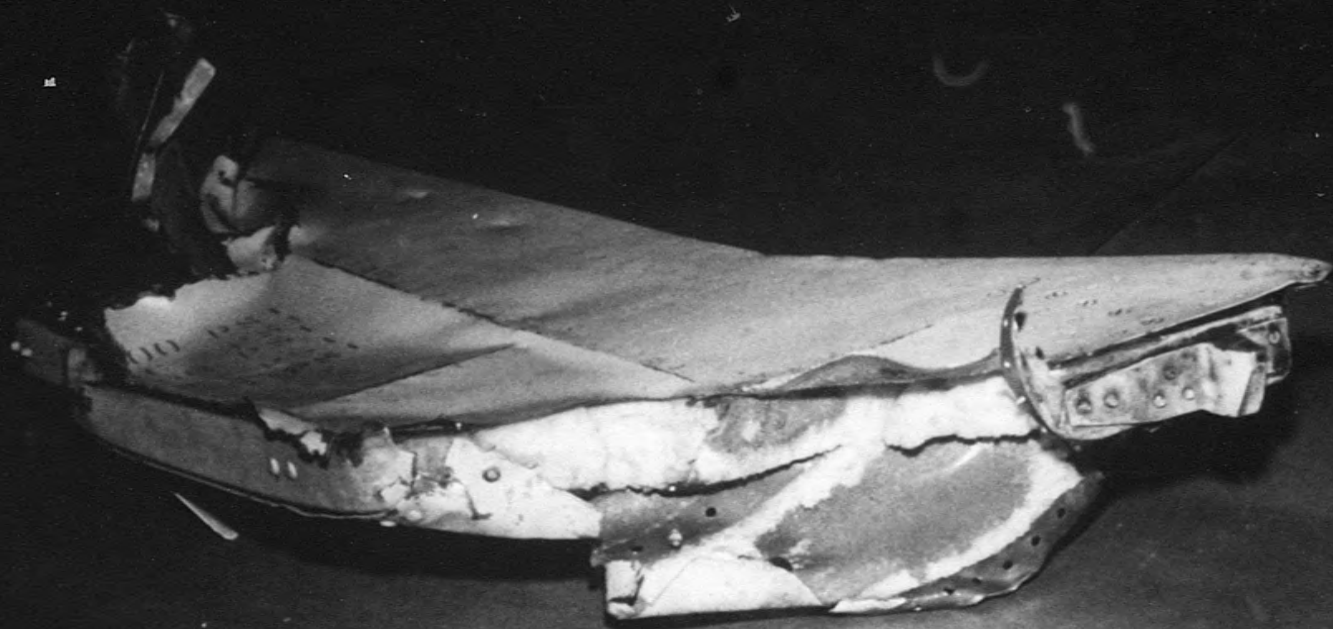
ENCLOSURE (18)

VF-74 SERIAL 2-65A, 26 NOVEMBER 1965, F4B BUNO 150410, PILOT MANFREDI
STARBOARD MAIN LANDING GEAR DOOR VIEWED FROM LOWER AFT SHOWING
OUTBOARD SURFACE. (NOTE WIDTH OF STYROFOAM PLASTIC FILLER)

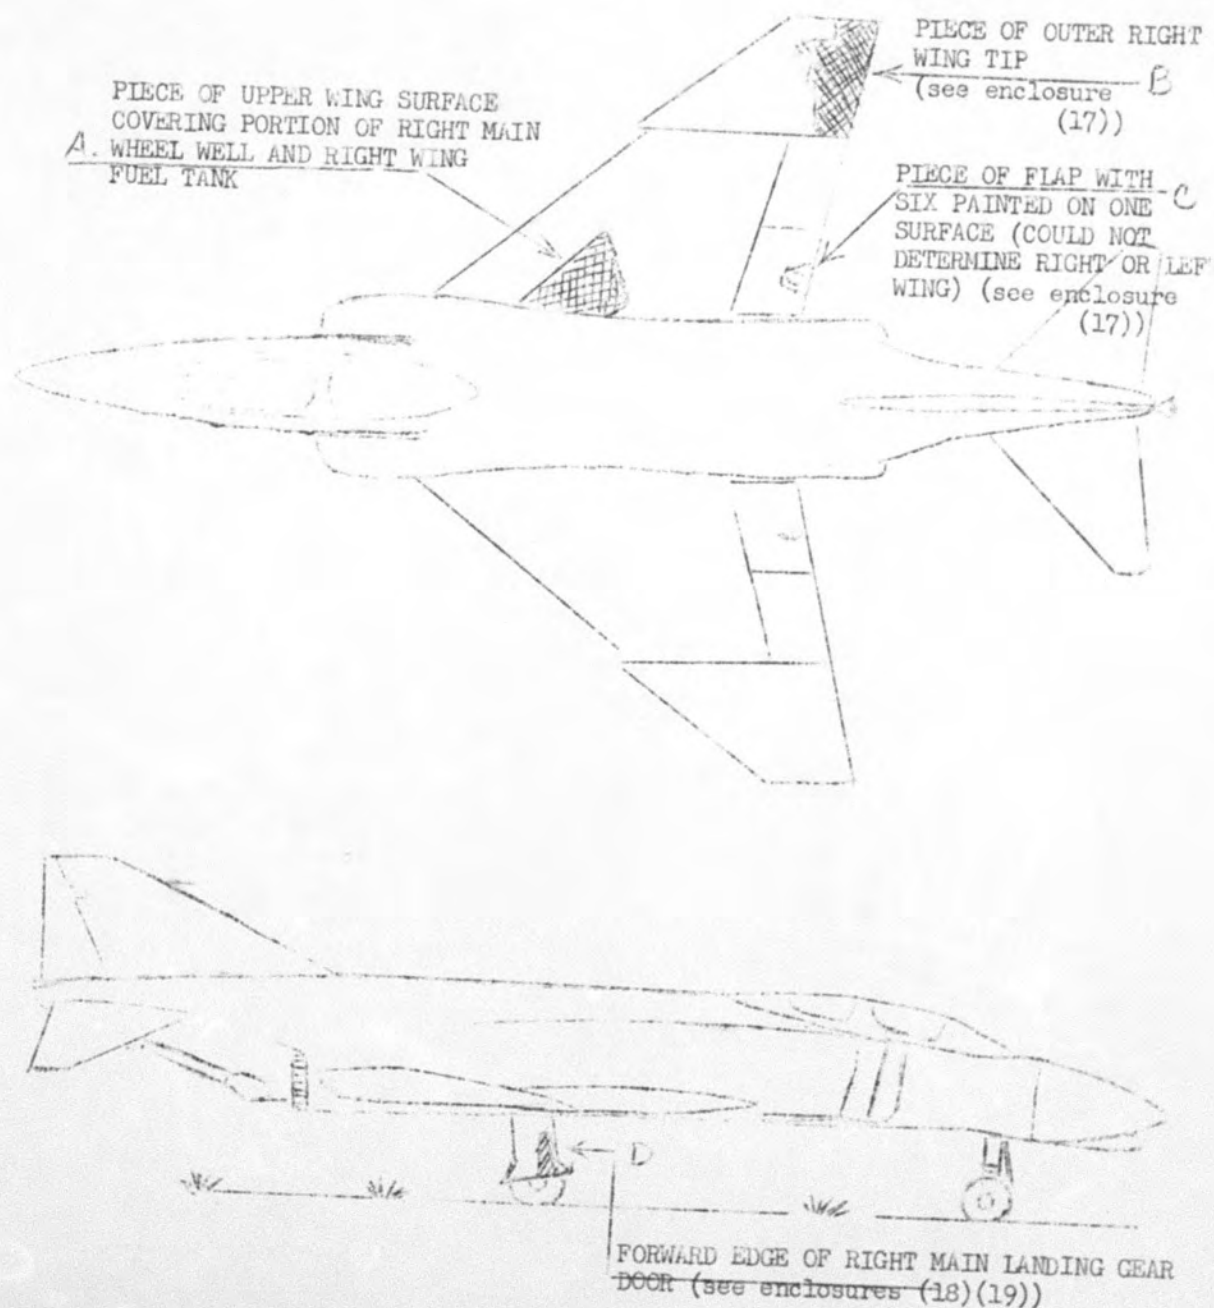
DIAGRAM OF F4B SHOWING LOCATION OF PARTS RECOVERED BY SEARCH OPERATION.

E THE PIECE OF STYROFOAM PLASTIC COULD NOT BE FITTED TO ANY OTHER PIECE OF WRECKAGE, HOWEVER, IT IS THE SAME THICKNESS AS THAT USED AS MAIN LANDING GEAR DOOR FILTER.
